**UNITED STATES ENVIRONMENTAL PROTECTION AGENCY
SUPERFUND SITE STRATEGY RECOMMENDATION - REGION 06**

Site Name: Delta Shipyard

Report Type, Date, and Author: SIP, June 15, 1995, ARCS

**SITE INSPECTION PRIORITIZATION REPORT
AND PRESCORE PACKAGE
DELTA SHIPYARD
PHASE III
HOUMA, LOUISIANA
EPA ID NO.: LAD058475419**

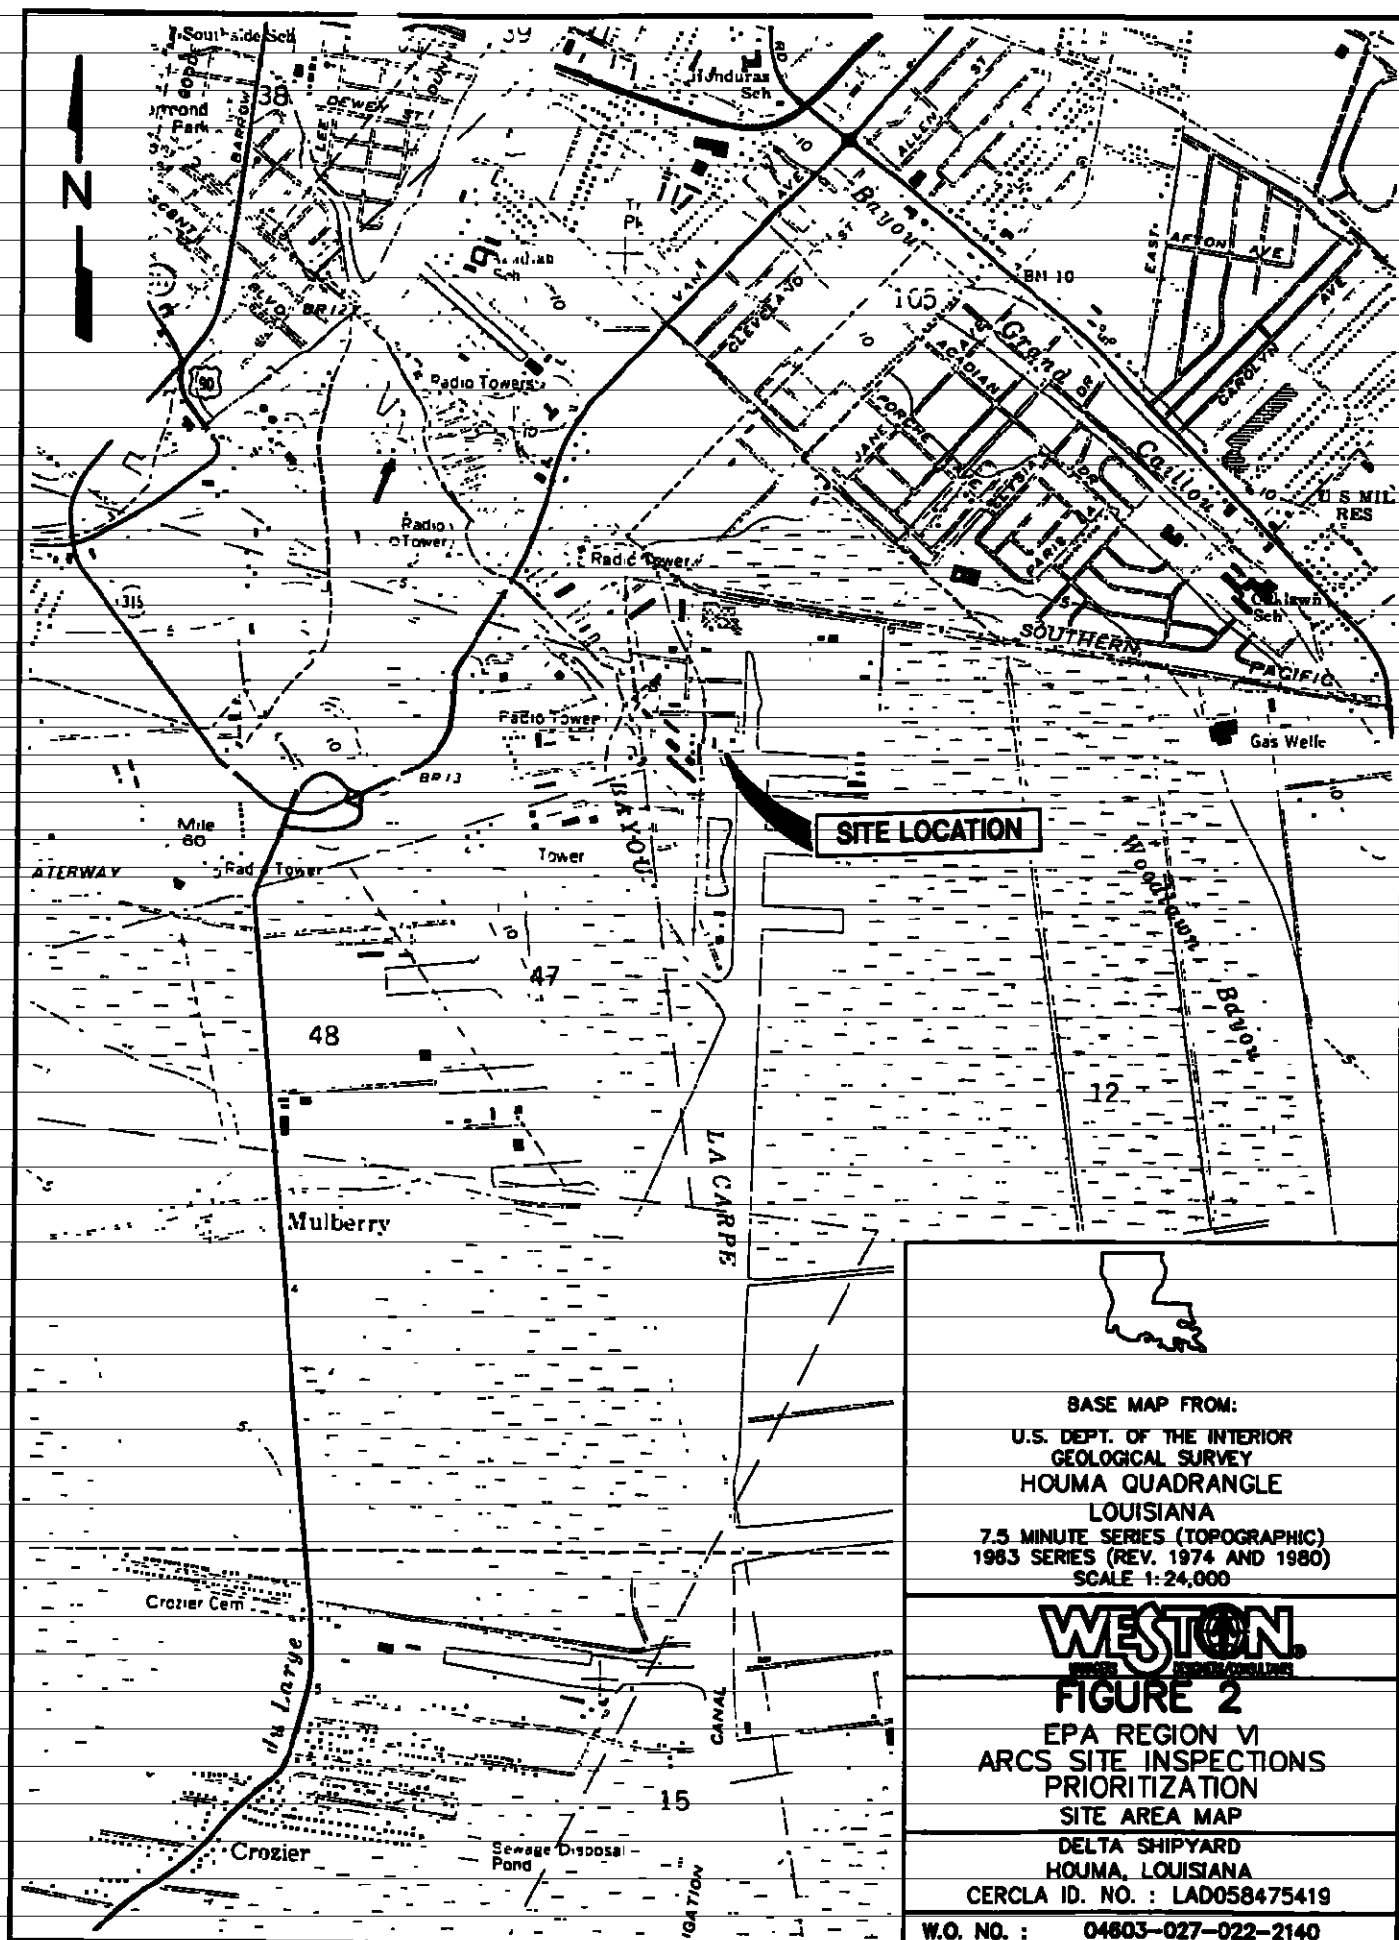
FIGURE 2

The DS site is located in Houma, Terrebonne Parish, Louisiana. The geographic coordinates of the site are approximately latitude 29°34'2" north and longitude 90°42'18" west. A Site Location Map is provided in Attachment 1 as Figure 1, and a Site Area Map is provided in Attachment 1 as Figure 2. The site can be reached by traveling south on Highway 90 into Houma until reaching East Main Street. Travel east on Main Street for approximately 1.8 miles and turn south on Howard Avenue. From Howard Avenue, travel south for approximately 2.2 miles until reaching Industrial Boulevard. Turn east and travel 0.5 mile. The site is on the south side of Industrial Boulevard.

EPA REGION VI
 ARCS SITE INSPECTIONS
 PRIORITIZATION
 SITE AREA MAP

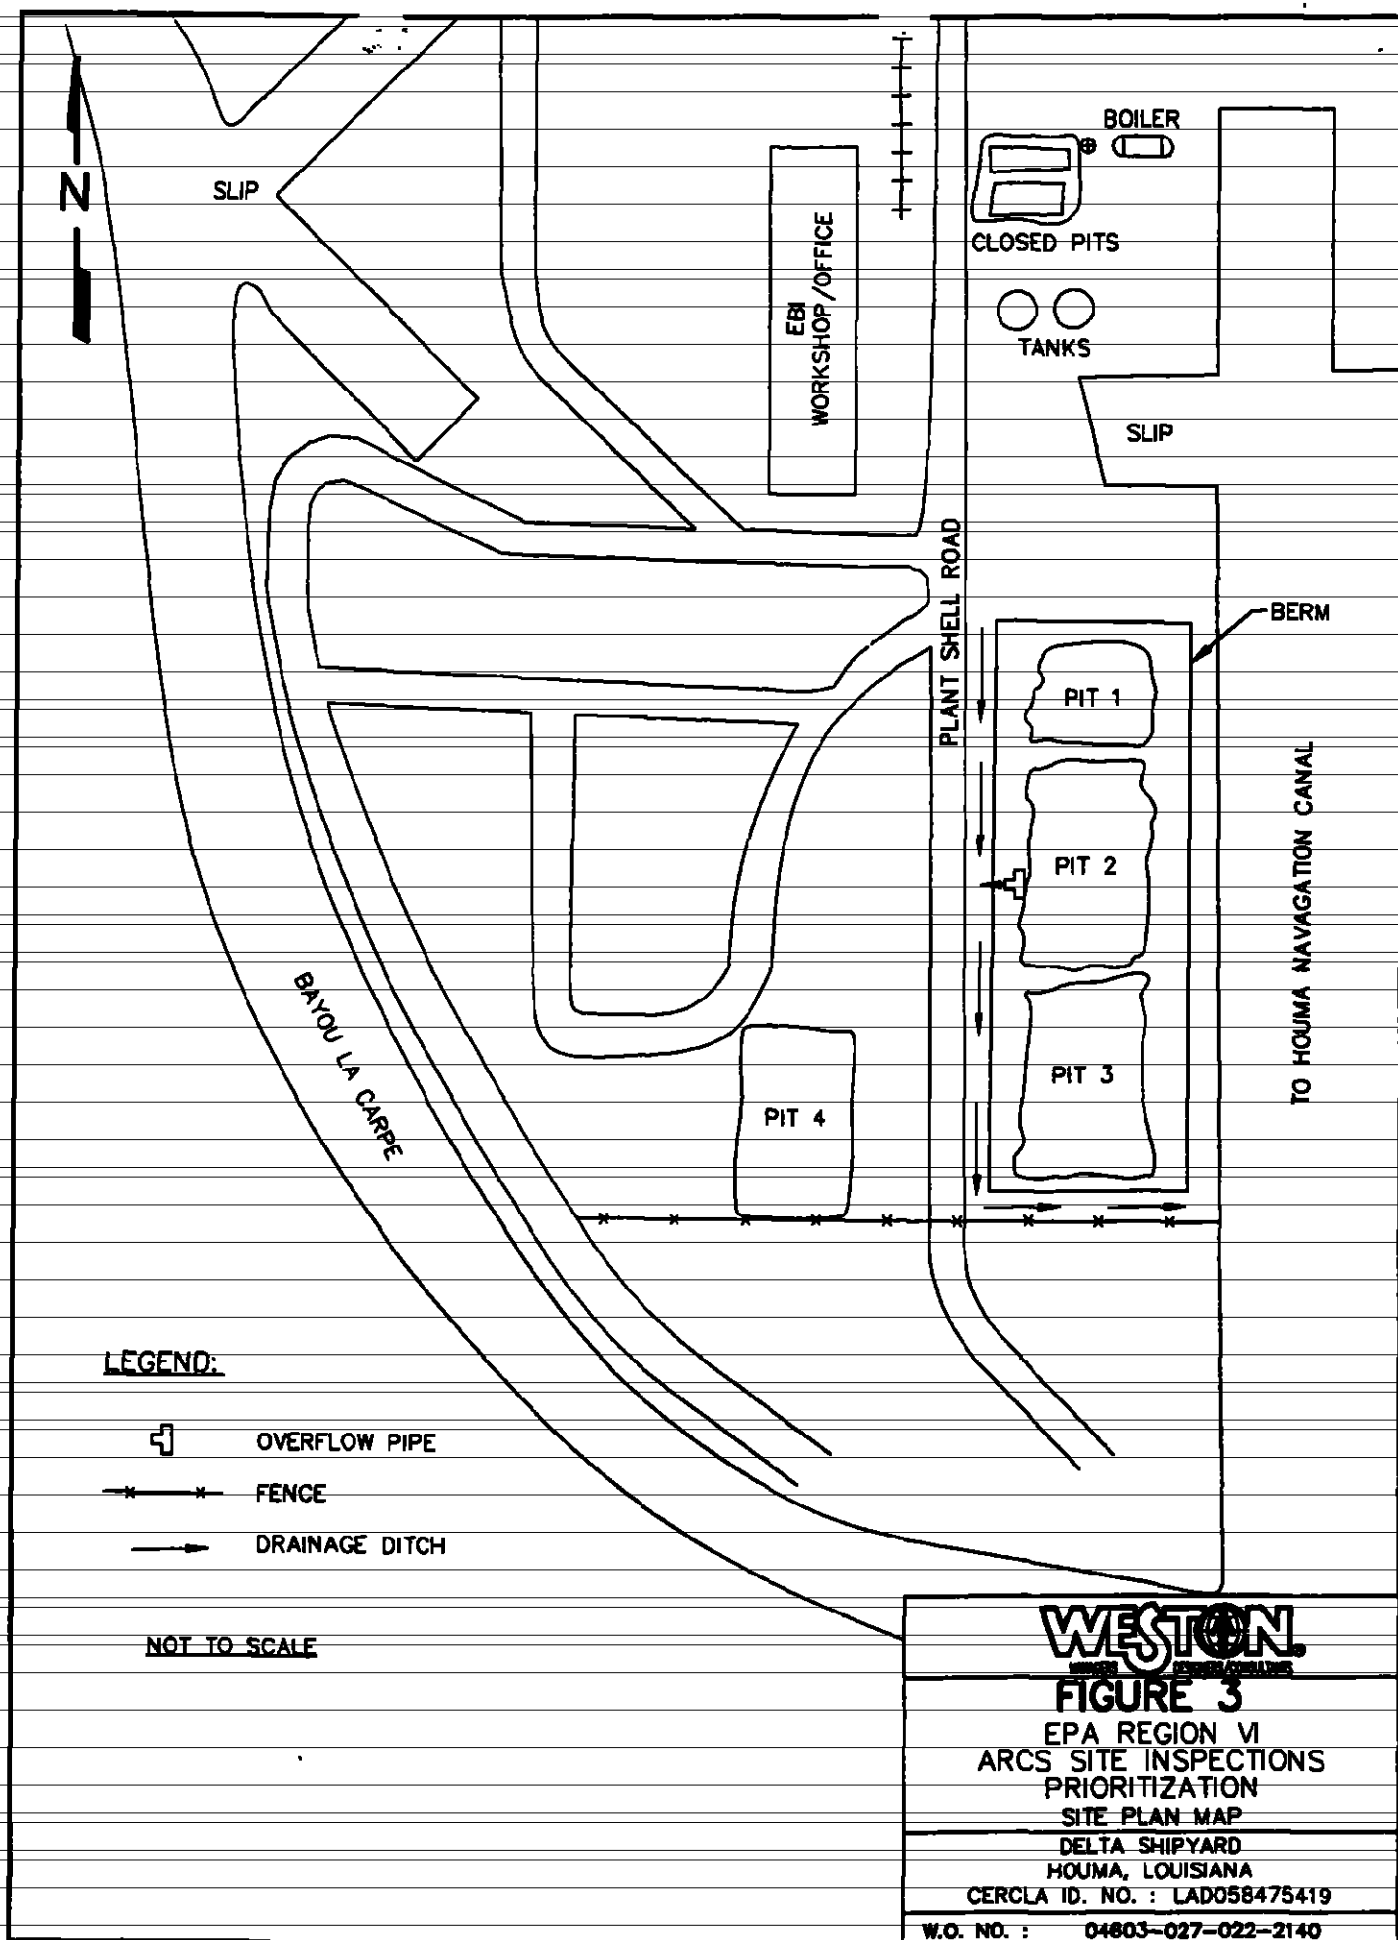
FIGURE 3

DS owned the site prior to EBI; the year operations began at the site is unknown. DS consisted of a barge gas-freeing operation and a cleaning and repairing facility for small cargo vessels, fishing vessels, and oil barges. The gas-freeing operation was required because the vessels had to be certified vapor free by the U.S. Coast Guard before repair work could commence. As part of the gas-freeing process, the vessels were steam-cleaned and the oily wastes were removed. The generated oils and wastewater were sent through a separation process after which the waste oil was recovered and sold. Wastes were stored in surface impoundments on-site. Two small waste pits, located approximately 100 feet east of the fabrication building, were sampled and closed in 1984 under the supervision of the Louisiana Department of Environment Quality (LDEQ) Hazardous Waste Division. Two monitoring wells are reportedly located around the closed pits; however, during the site reconnaissance, only one could be located. The pits were reportedly used to dispose of waste oil and oil field drilling material. A Site Plan Map is provided in Attachment 1 as Figure 3.

The DS site contains old gas-stripping equipment (i.e., storage tanks, separator, boiler) left behind from the former operation. The two closed waste oil surface impoundments are now a parking lot used by EBI employees. Four larger pits are located approximately 800 feet south of the fabrication building and are surrounded by dense vegetation. One pit is located west and the other three are located east of Plant Shell Road. According to a Wink Engineering sampling report in 1985, the pit west of the road is actually three pits in series that have been covered over with fill material. For the purposes of this Phase III report, these pits are considered one single pit. The three pits east of the road are exposed and covered with a crusty black substance. At the time of the site reconnaissance, rainwater containing an oily sheen was pooled on the surface of the pits.

SITE PLAN MAP

Four waste source areas were identified in the file review and site reconnaissance. They consist of four pits used to store waste oils from the DS ship cleaning and repair operation. Pit 4 is actually three pits according to a Wink Engineering report; however, the pits are aligned in series, covered over, and vegetated. For purposes of the Phase III report, they are designated together as Pit 4. The other three pits (1, 2, and 3) are exposed and covered by a black crusty substance. Pits 1, 2, and 3 are elevated and surrounded by a 3- to 6-foot berm. The four pits together have an approximated surface area of 294,000 square feet. The waste characteristics of the site were assessed for the groundwater, soil, and surface water exposure pathways.

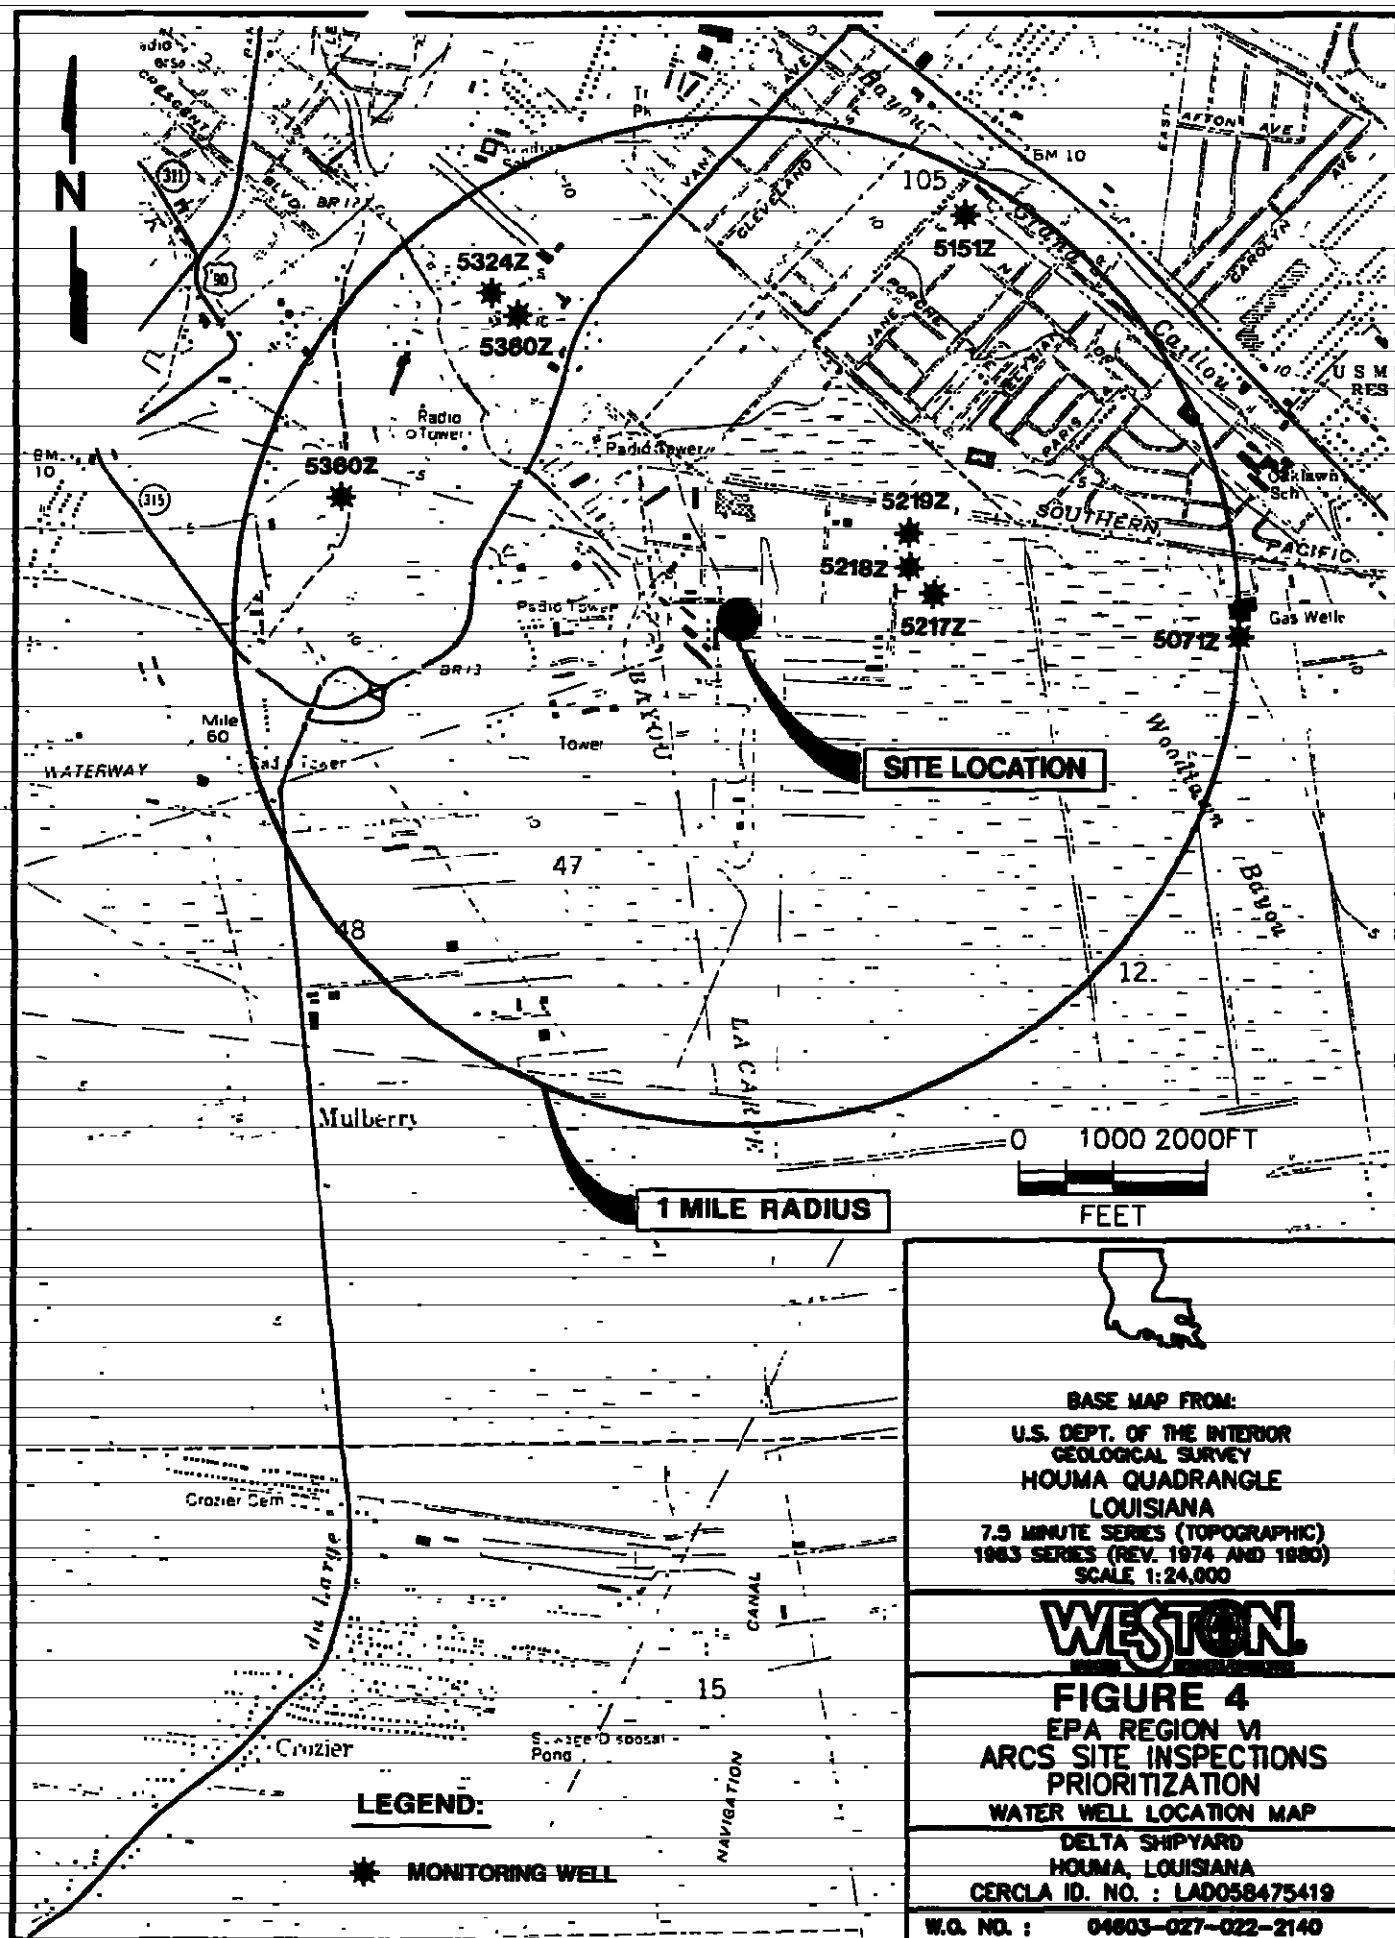
WESTON used file information from EPA VI and contacted the Louisiana Department of Transportation (LDOT) for information on water wells within a 1-mile radius of the site. LDOT files indicate several monitoring wells and 1 rig supply well are located within a 1-mile radius of the site. The rig supply well is plugged and abandoned. The closest wells are three monitoring wells located 2,000 feet to the northeast of the site. They are owned by Torch Energy and are completed in the Mississippi River Alluvial Aquifer Confining Unit. They were drilled in 1990 and range from 7 to 10 feet deep. A Water Well Location Map is provided in Attachment 1 as Figure 4.

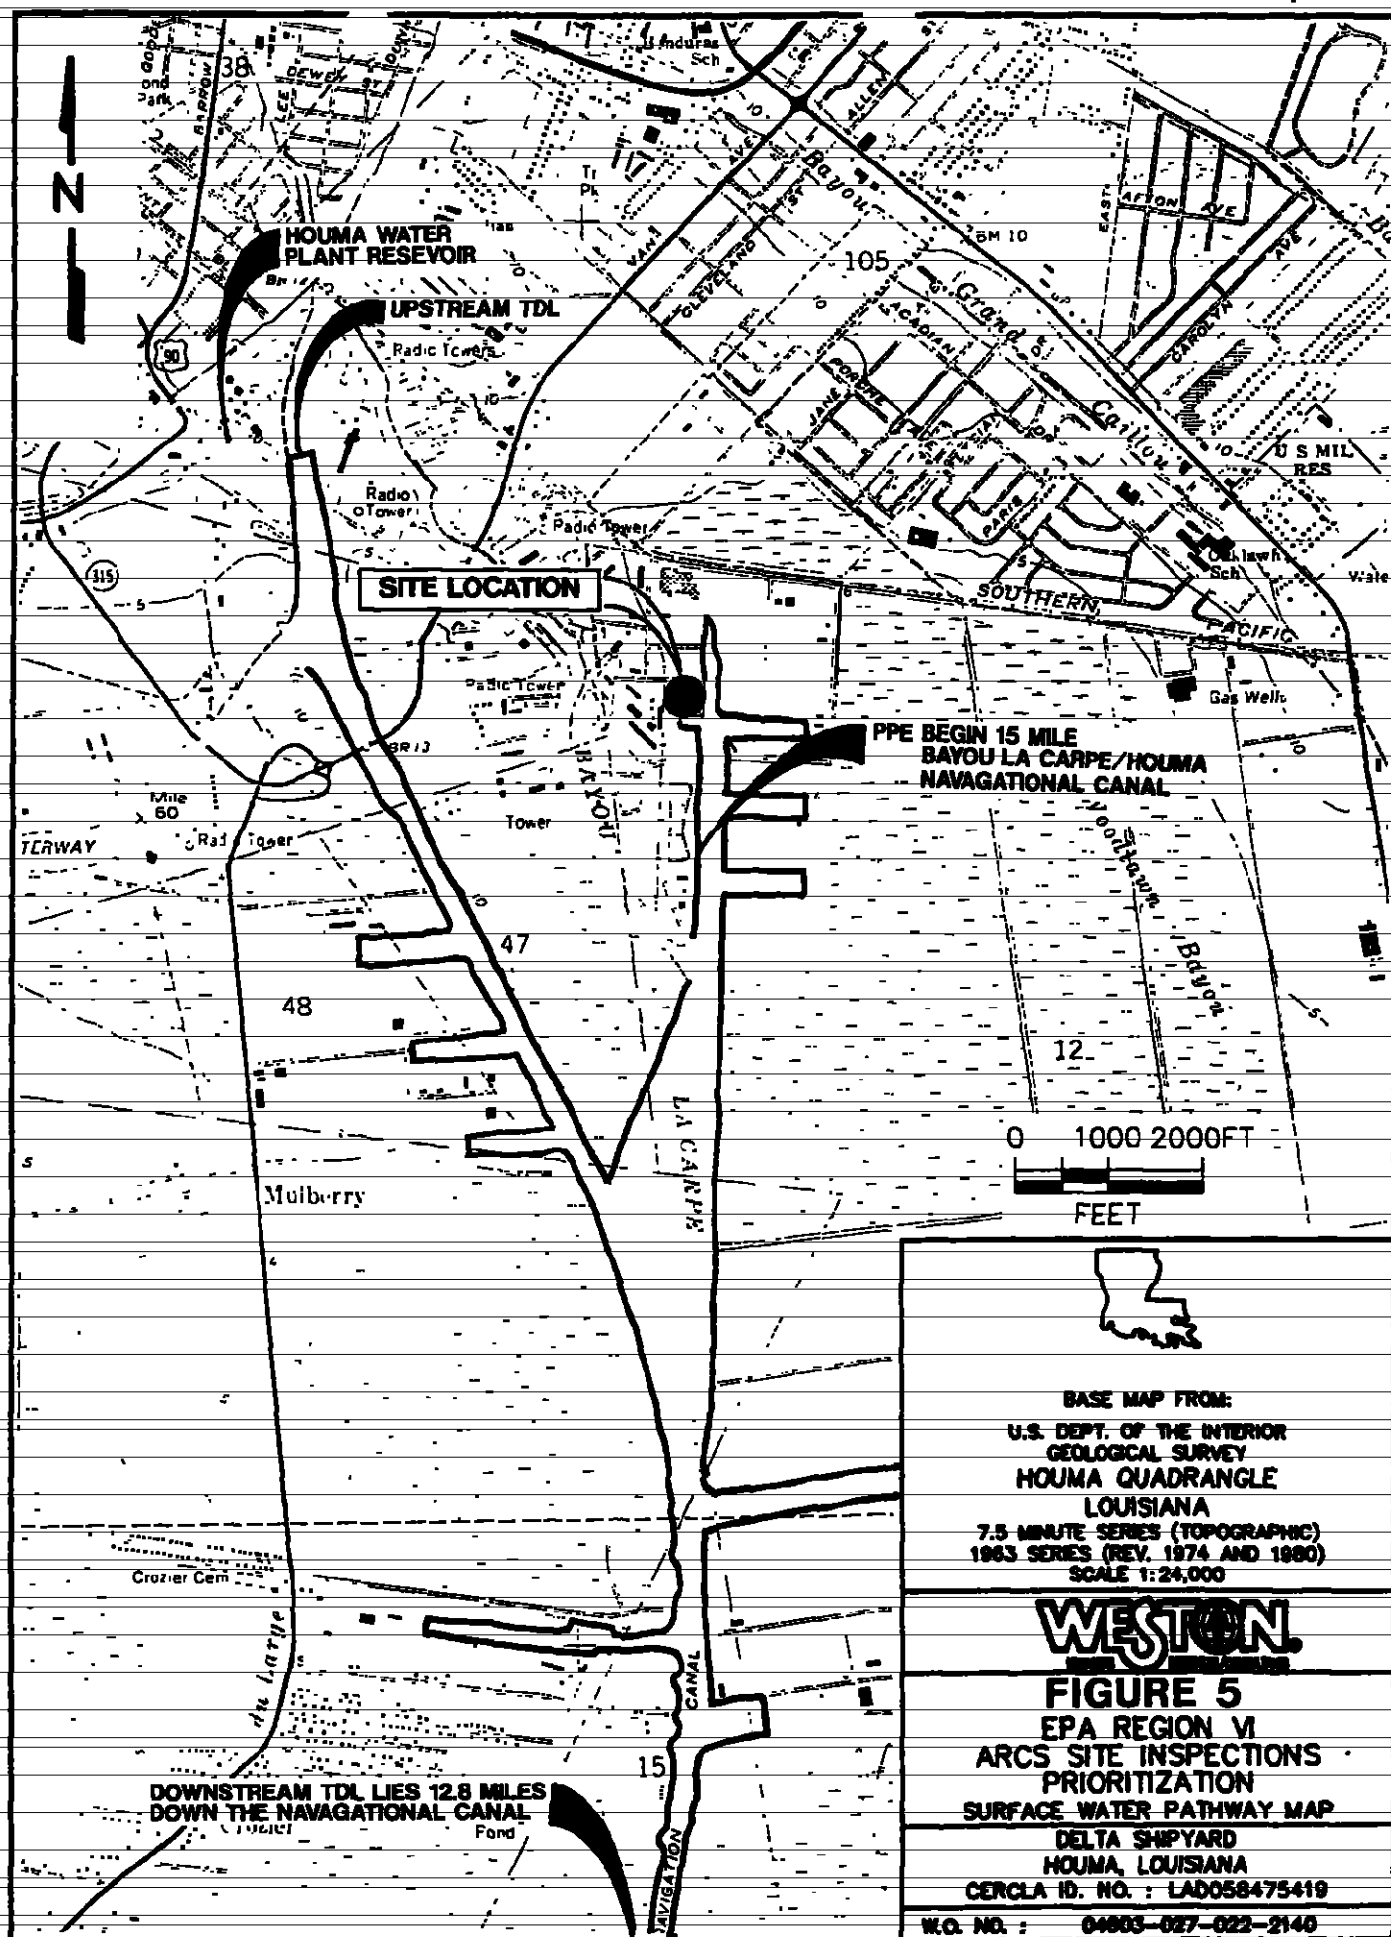
Surface water runoff draining from the site flows into Bayou La Carpe. Bayou La Carpe enters the Houma Navigational Canal just south of the site. According to the Houma, Louisiana, 7.5-minute wetlands map, the Houma Navigational Canal is bordered by extensive wetland areas. A Surface Water Pathway Map is provided in Attachment 1 as Figure 5.

Sediment samples collected from the drainage ditch surrounding Pits 1 through 3 indicate the presence of several semivolatile organics and metals. Sediment analytical results reported at concentrations exceeding three times background concentrations are summarized in Attachment 3, Tables 2 and 3. A Surface Water Pathway Map is provided in Attachment 1 as Figure 5.

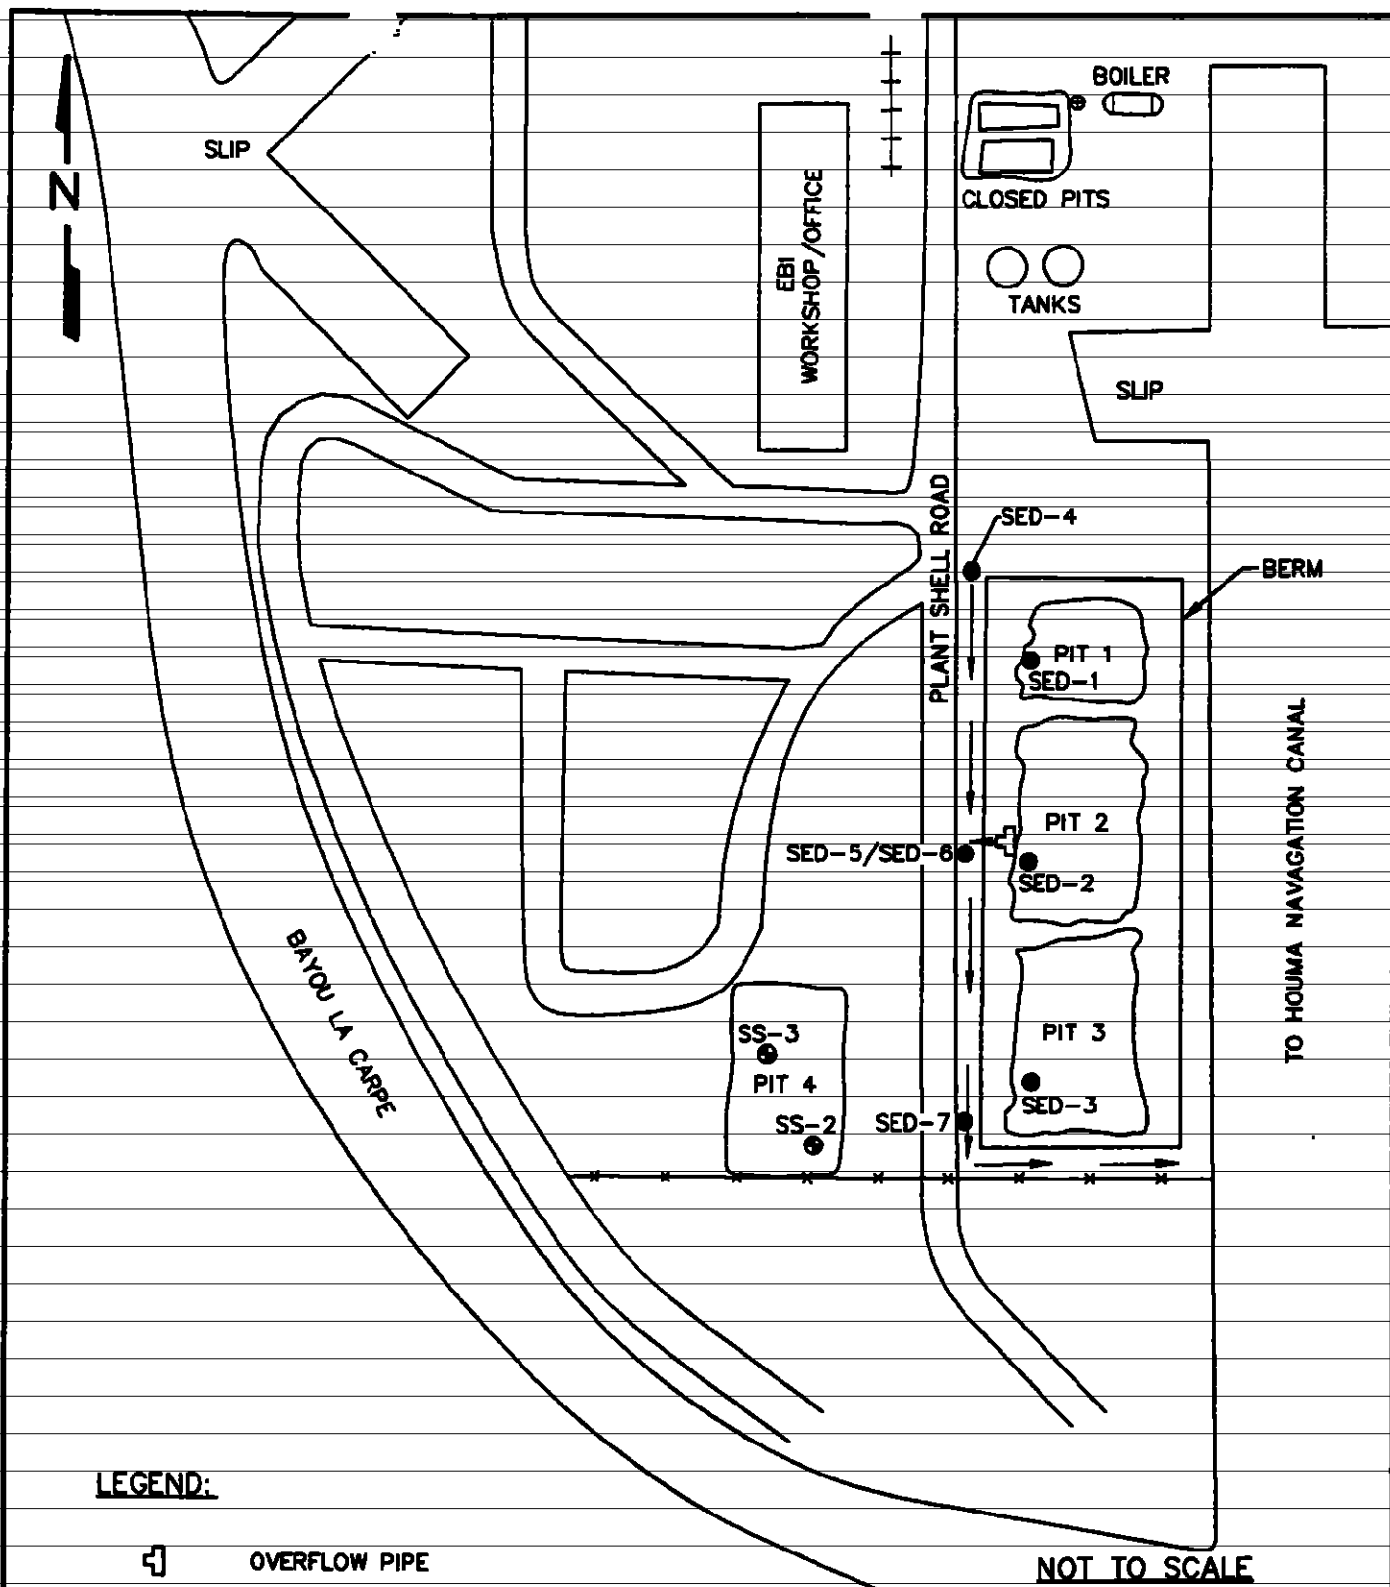
FIGURE 6

WESTON collected seven sediment samples (SED-1 through SED-7) and three soil samples (SS-1 through SS-3) in an effort to document the presence and migration of hazardous substances associated with the potential hazardous waste source areas (HWSAs) at the site. Sample locations are shown in Attachment 1 as Figure 6. SIP soil/sediment sample locations, descriptions, and rationales are summarized in Attachment 3 as Table 1.

SS-1 IS TAKEN OFFSITE AS A BACKGROUND SAMPLE.

EPA REGION VI
ARCS SITE INSPECTIONS
PRIORITIZATION
SAMPLE LOCATION MAP

The laboratory analytical results for soil samples SS-2 and SS-3 and sediment samples SED-1, SED-2, and SED-3 were collected from the pits during the SIP and can be used to characterize the potential HWSAs.

The laboratory analytical results for sediment samples SED-4 through SED-7 collected during the SIP can be used to characterize the potential for contaminant migration in the surface water pathway. A drainage ditch runs along the west and south ends of Pits 1 through 3. An overflow pipe on Pit 2 drains rainwater from the pit into the ditch. Surface water draining from the pits follows the ditch approximately 0.3 mile until reaching the probable point of entry (PPE) at Bayou La Carpe. Bayou La Carpe flows approximately 4,000 feet south until reaching the Houma Navigational Canal. The Houma Navigational Canal is tidally influenced. Due to the tidal influence, two TDLs are assigned to the site, TDL-1 and TDL-2. TDL-1 is located approximately 2.55 miles upstream of the PPE at the water plant, the farthest point where saltwater intrusion has been documented. TDL-2 is located 15 miles downstream in the Houma Navigational Canal.
